Manhole Inspection Summary

Manhole # S49II_009MH

Insp Date: **5/14/08 1:04 PM**

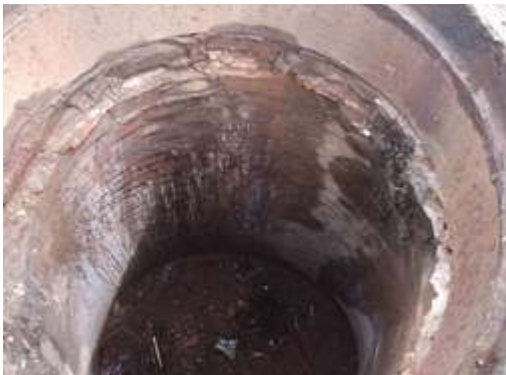
Defect 1

Infiltration: ☐ None ☒ **Joint** ☐ Cracks ☒ **Mortar** ☐ Roots ☐ Wall

Infiltration: ☐ None ☐ Joint ☐ Cracks ☐ Mortar ☐ Roots ☒ **Wall**

Infiltration

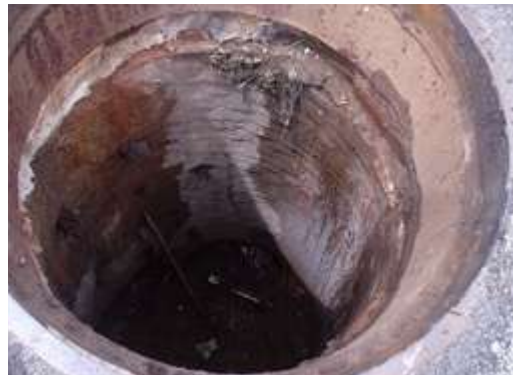
Defect 2

Condition: ☐ Sound ☐ Cracked ☐ Root Intrusion ☒ **Loose Brick** ☐ Deteriorated

loose brick

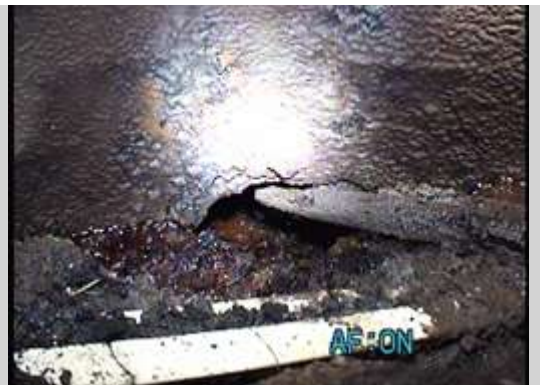
12 O'Clock Outflow

can't get good pic because of derbi
